TWIN CITY LINES

SUMMER 2009

THE DOUBLE DECKERS

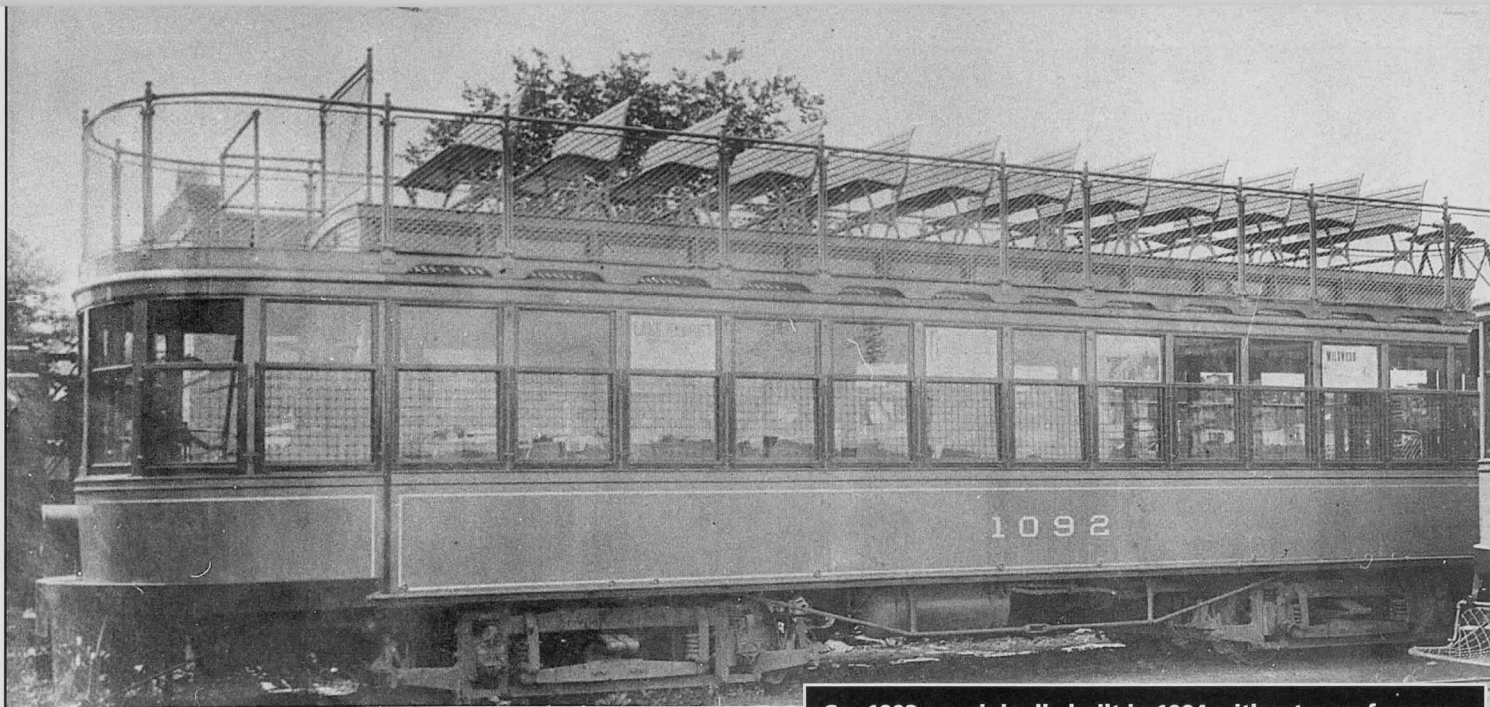
Car 1092 as originally built in 1904 without a roof canopy.

Beginning in 1903, TCRT began considering an experiment with double deck streetcars. The first drawings for a proposed double deck car were dated July 1903. The standard car design was modified by:

1. Moving the trolley base to a stand at the extreme rear.
2. Reinforcing the deck roof and installing 12 transverse four-passenger benches on the roof.
3. Laying a walkway on the lower roof on either side of the benches (about 15 inches from the top of the deck roof).
4. Installing entrance steps with a single pair of folding gates on the front platform together with a straight stairway from the steps to the roof that angled over the motorman's position.
5. Enclosing the upper deck structure with a waist-high framework of gas-pipe railings and wire screening.

The first car selected was number 1092, being completed July 1, 1904, before work was begun on an earlier order for cars 1042-1091. Upon completion the car was placed in sightseeing and charter service. Trial runs were reported on 8-31-04 and 9-27-04.

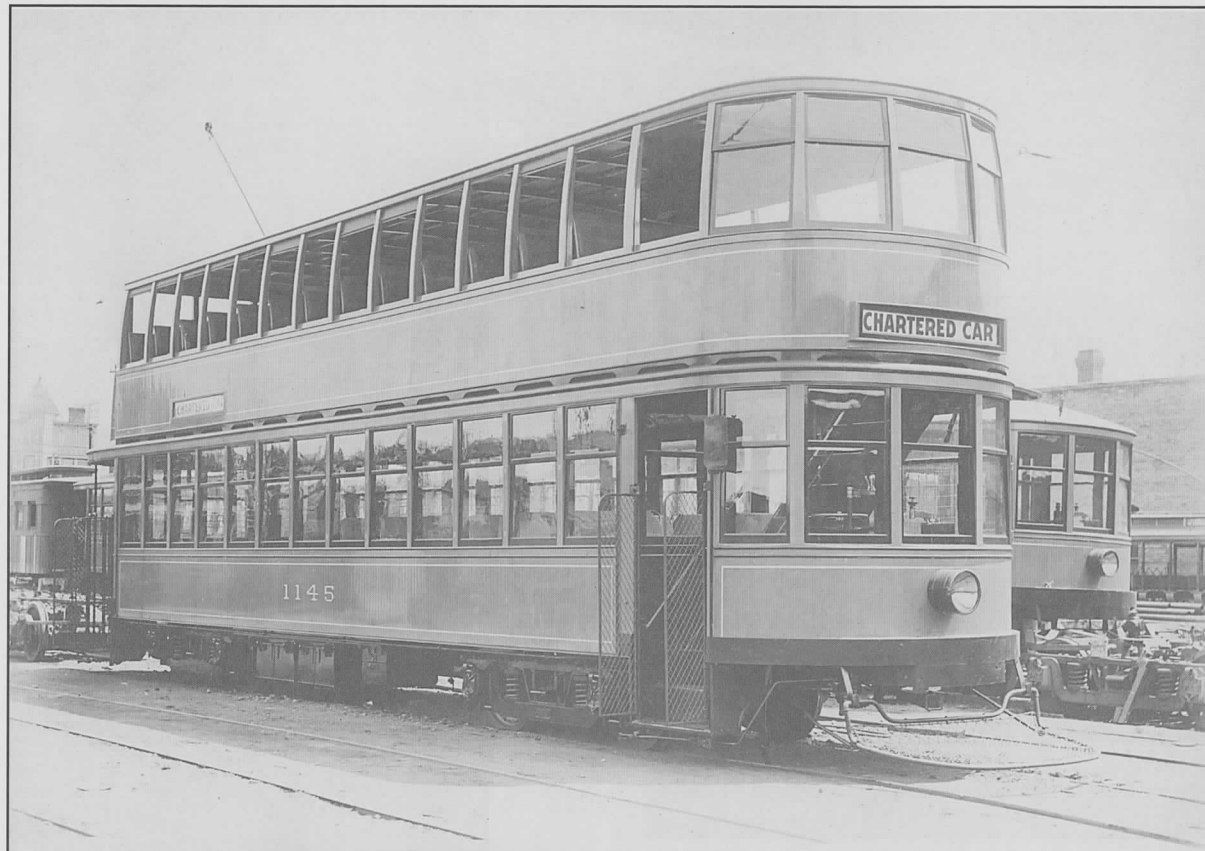
Car 1145 in the 31st Street Station yard, probably in 1906. Note that only the front windows have glass. Pull-down shade offer weather protection in all the other windows. The hand written caption by Everett Jones says "Double deck Lake Minnetonka car used very little."

Plans for a more substantial double deck car were begun in October 1905. Spare Work Order (S.W.O.) 8737 provided for building one double decker. This was car 1145, completed May 25, 1906. A single track line from Lake Harriet to Excelsior had been opened during September 1905.

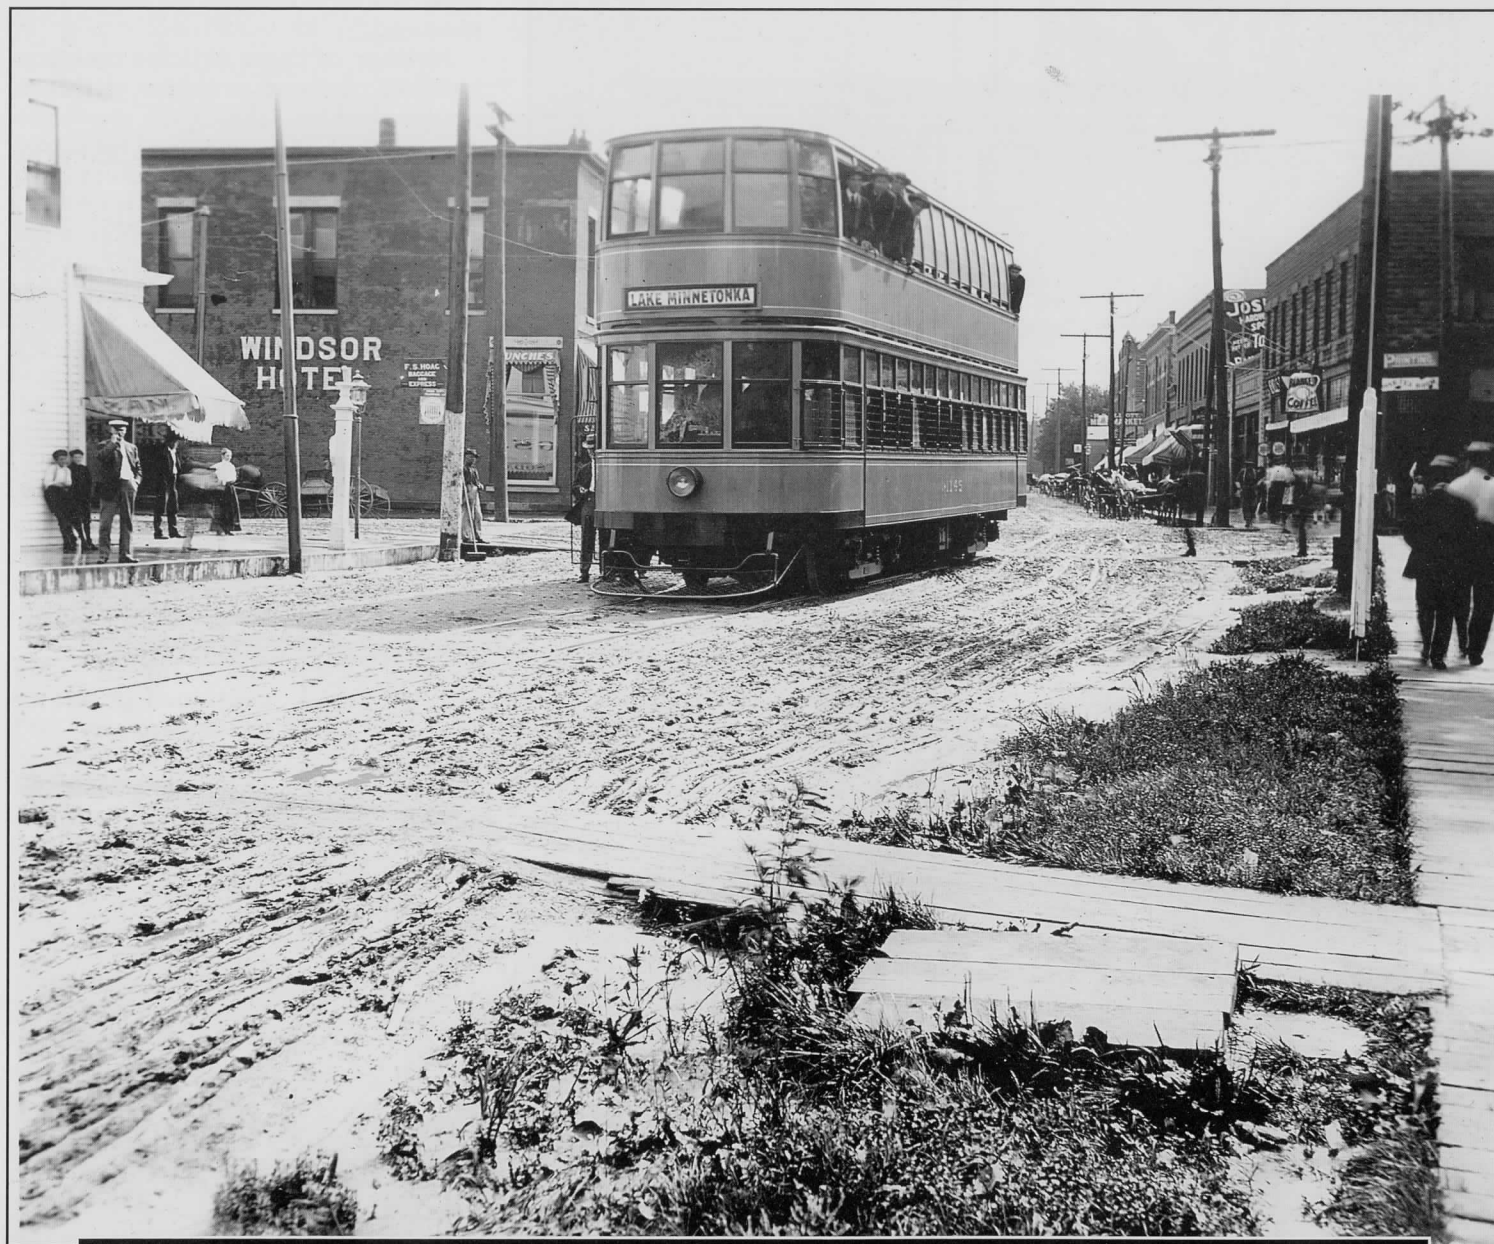
This oft-published 1906 photo is the only one that show car 1145 in service, at 2nd and Water Streets in Excelsior

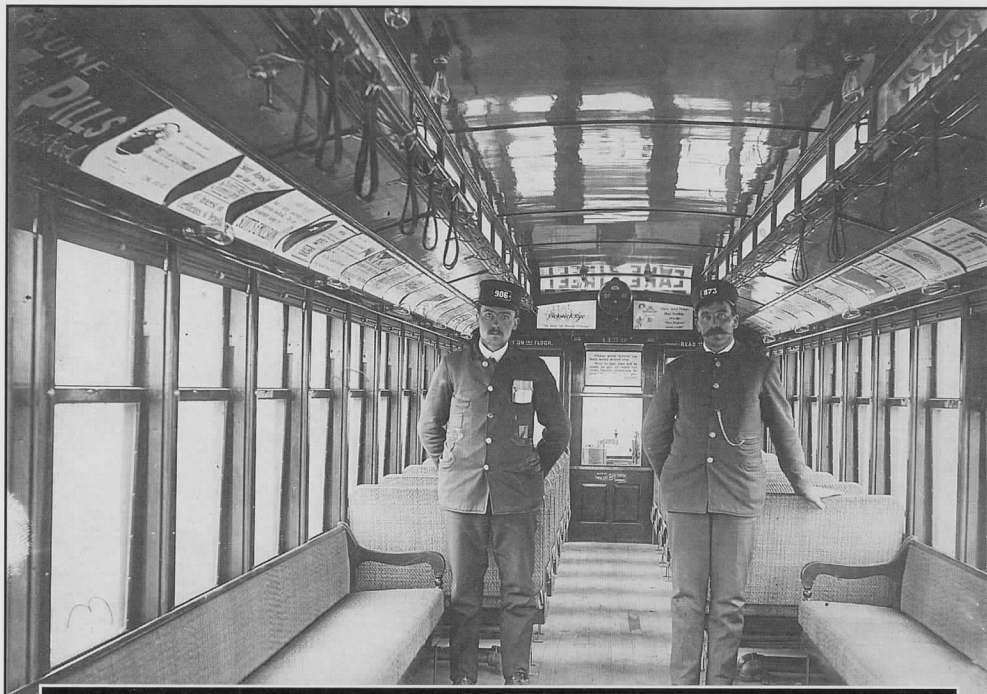
Compare the thickness of the window posts in car 1159 (top), built for double decking, with car 1573, built several years later. By the way, guess which employee is the conductor and which is the motorman. The conductor is at left. Compare the number of pockets in their coats. Conductors needed more on-body storage. Also, conductors were assigned even badge numbers, motormen odd numbers.

To provide for the addition of the upper deck and the load on the roof the body framing was built somewhat heavier than otherwise. The width of the corner posts was increased and the roof carlines were reinforced, so that with the full load on the upper deck the deflection by actual test does not exceed 1/16 inch. At every post the wood carlines are reinforced by steel carlines. In the forward portion of the car, where the presence of the (destination) sign necessitates an extra width of upper window, the steel carlines are 1 inch by 2 7/8 inches."

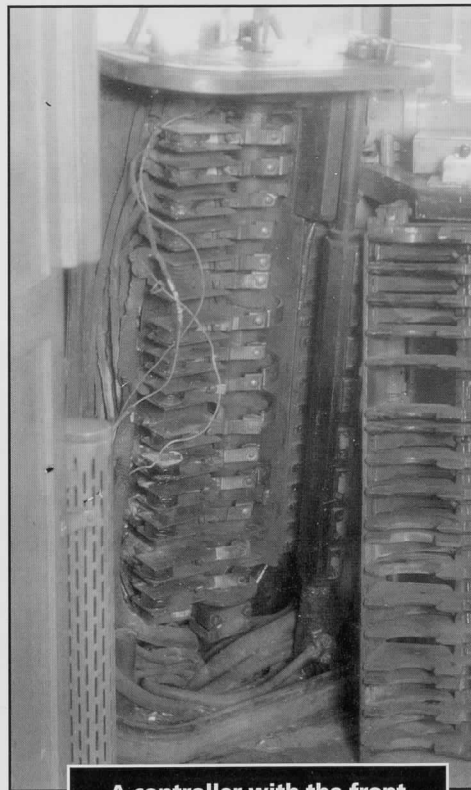
A controller with the front cover off reealing the rotating drum with "finger" contacts.

The practice of using oiled waste on the master controller fingers must be stopped at once. Motormen will promptly report any defect in the operation of controller to Station Foreman and allow shop men to remedy it.

Controller contacts were normally lubricated with Vaseline, which could withstand much of the arcing at the contacts. It also tended to maintain a lubricating coating on the surfaces of the finger contacts and drum segments. Oil would not maintain that lubricating film,

and dry contacts are more prone to arcing, as well as increased wear. There is also the hazard of shards from the cotton waste being shed upon the contacts, leaving oily remnants that could catch fire quite easily. In addition, those shards could prevent proper contact between the fingers and the segments, possibly exacerbating the arcing problem.

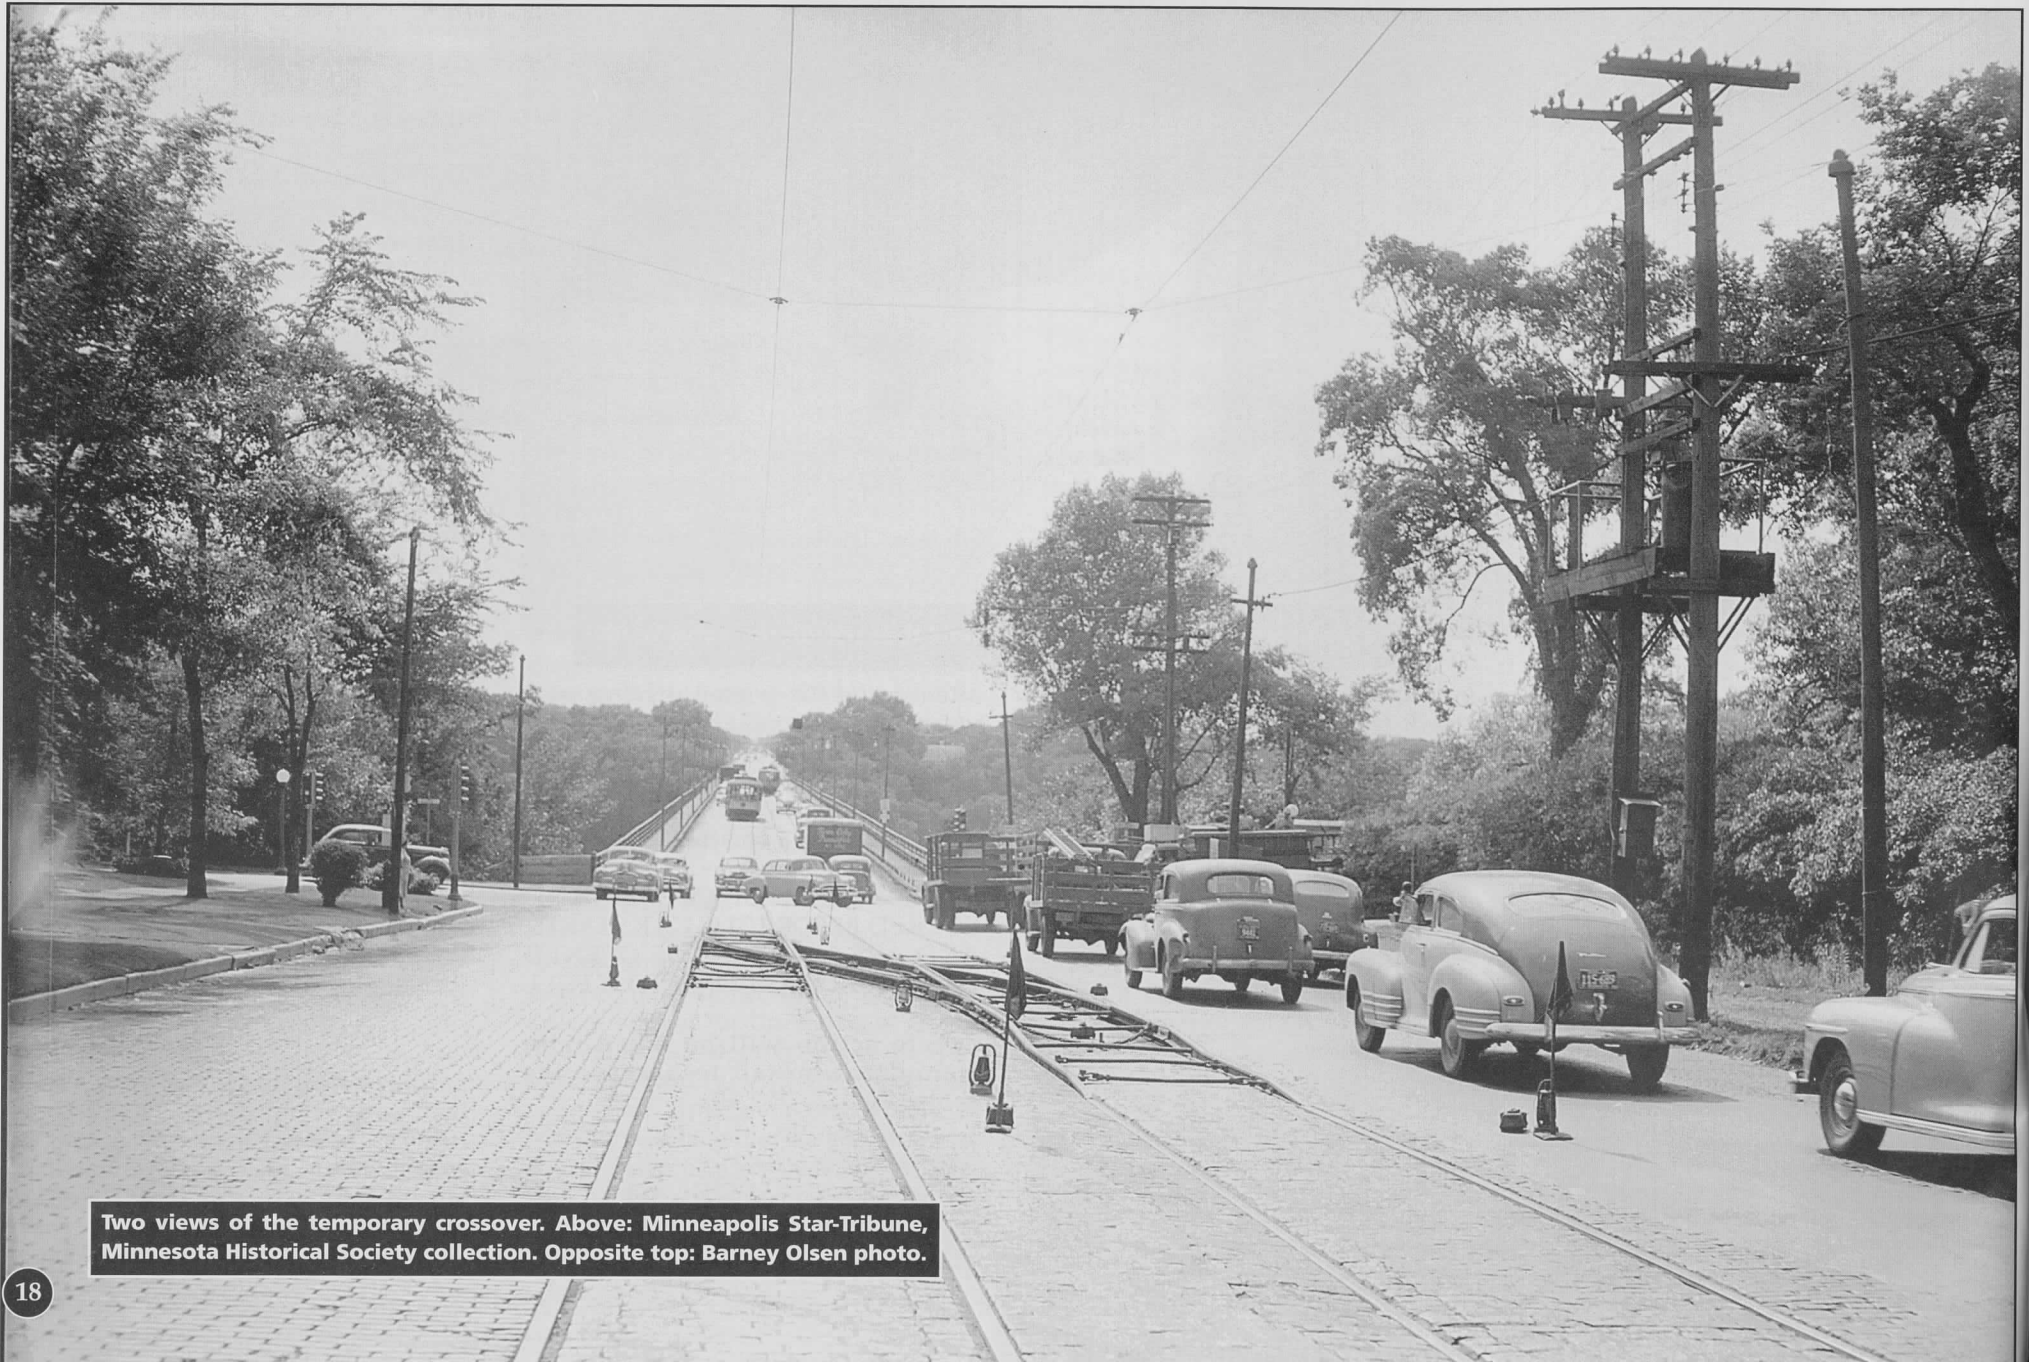
Two views of the temporary crossover. Above: Minneapolis Star-Tribune, Minnesota Historical Society collection. Opposite top: Barney Olsen photo.

In 1950 the 45-year old Lake Street bridge over the Mississippi River received a new deck. Streetcar service was maintained by removing one track from service, replacing that portion of the deck, and then shifting to the other side. A temporary crossover was installed at the St. Paul end of the bridge.

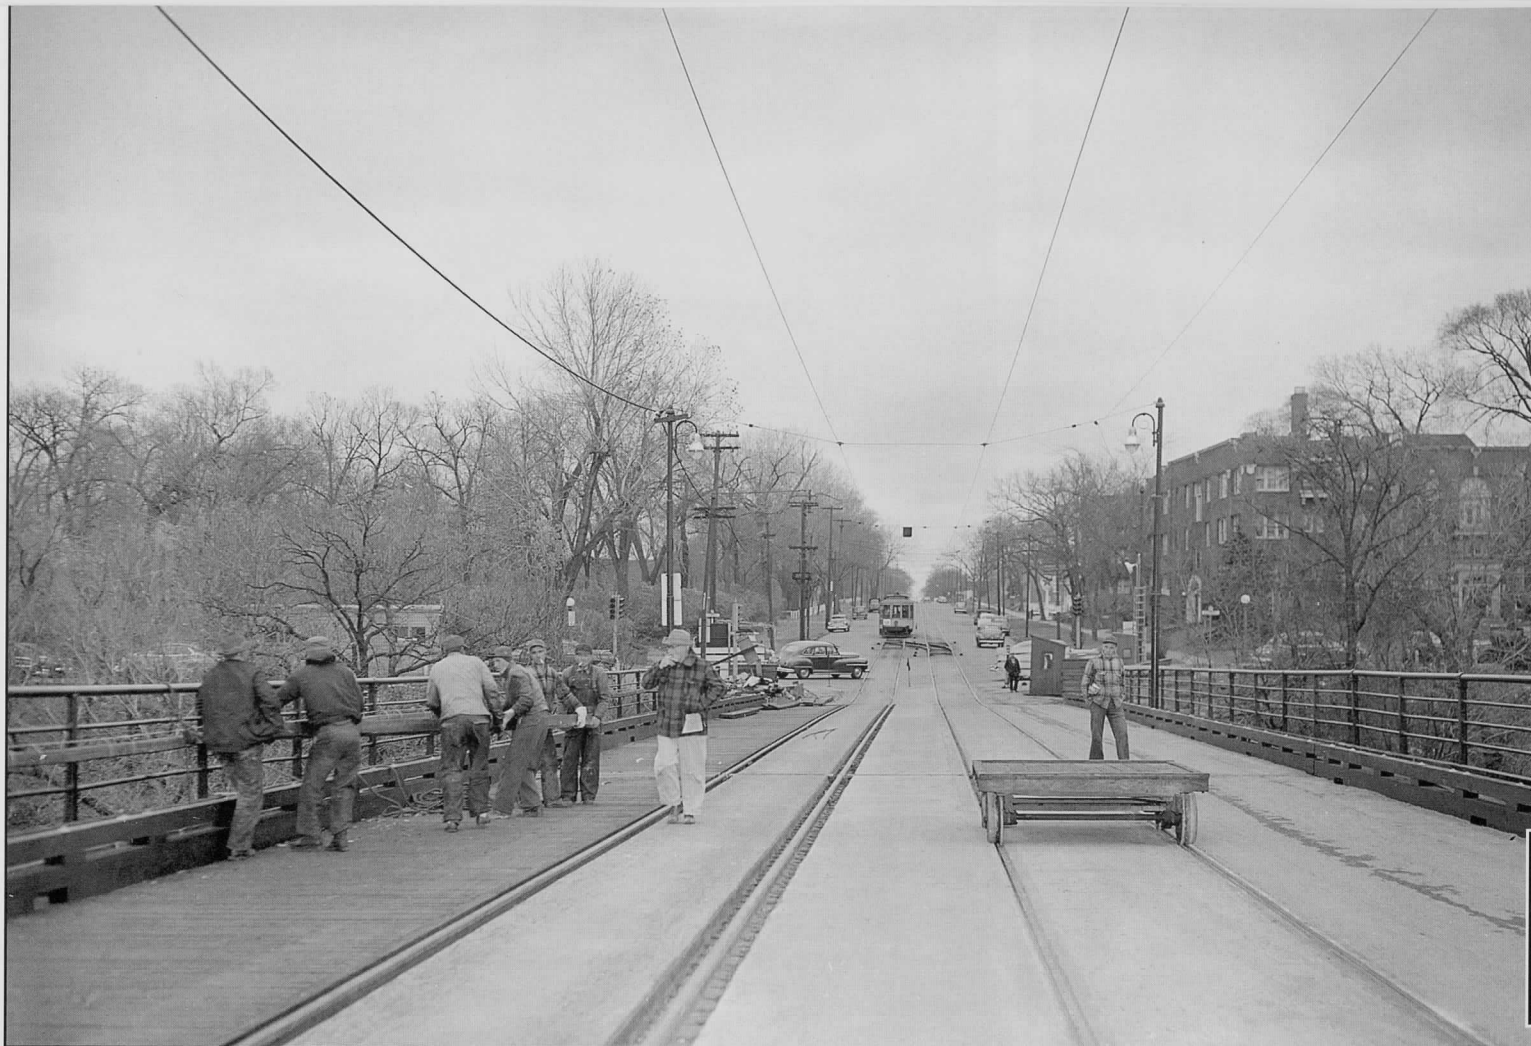
The Lake Street bridge during redecking, looking toward the St. Paul end (above), and the barriers at the Minneapolis end. Minneapolis Star-Tribune, Minnesota Historical Society collection

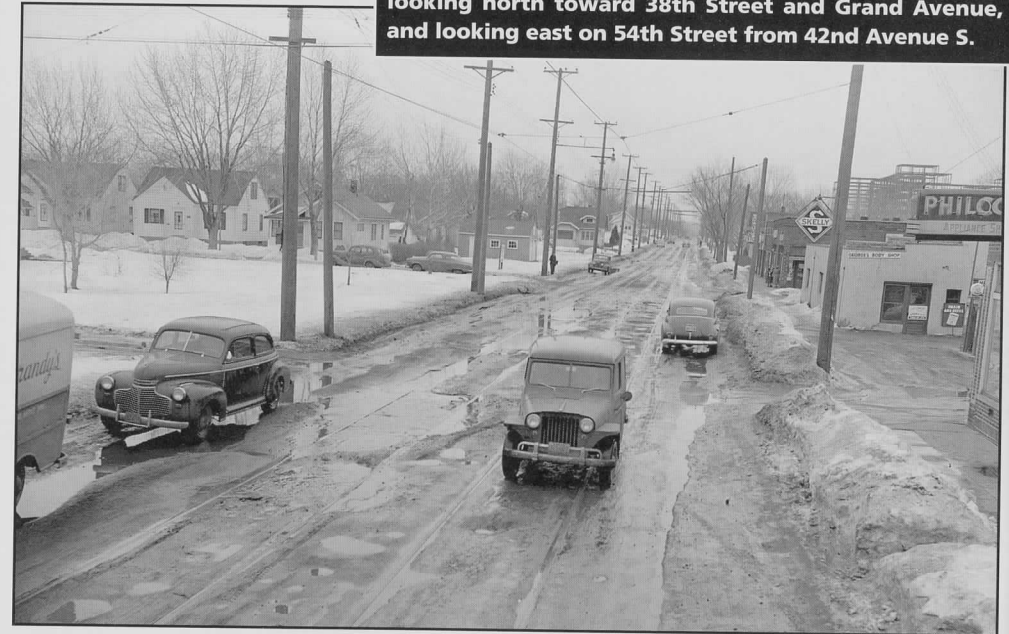
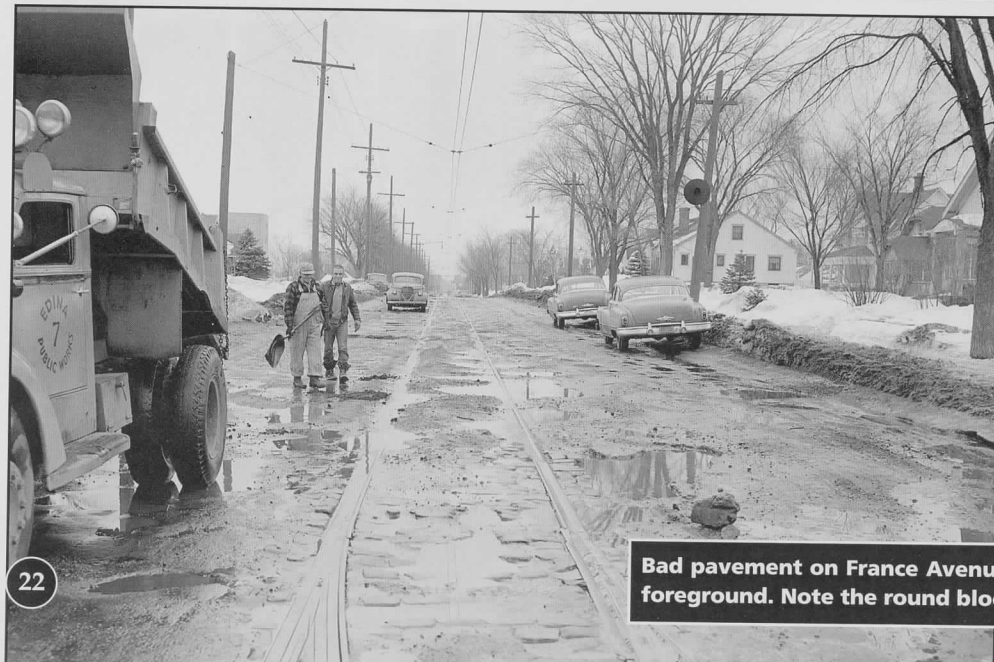
Bad pavement on France Avenue S. at 45th Street (right) and 54th Street. That's the wye switch in the foreground. Note the round block signal for the single track on the pole above the nearest parked car.
